1. REPORT NUMBER CERL-TR-M-120	2. GOVT ACCESSION NO.	3. RECIPIENT'S CATALOG NUMBER AD-A008 996
4. TITLE (and Subtitle) FAILURE ANALYSIS OF TAINTER GATE CABLE-ADJUSTING BOLTS		5. TYPE OF REPORT & PERIOD COVERED FINAL

FAILURE ANALYSIS OF TAINTER GATE CABLE-ADJUSTING BOLTS

Objective and Scope. The objective of this investigation was to determine the cause of failure of the eight cable-adjusting bolts at Uniontown Dam and to recommend a means to minimize the probability of future failures.

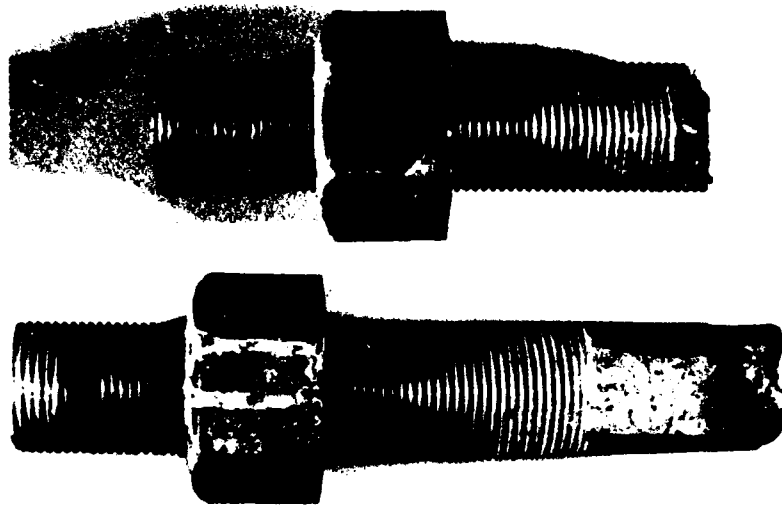
Two of the broken bolts received by CERL are shown in Figure 5. Inspection of these bolts, along with their corresponding nuts, revealed that they had not been completely painted.

Figure 5. Fractured bolts as received by CERL.

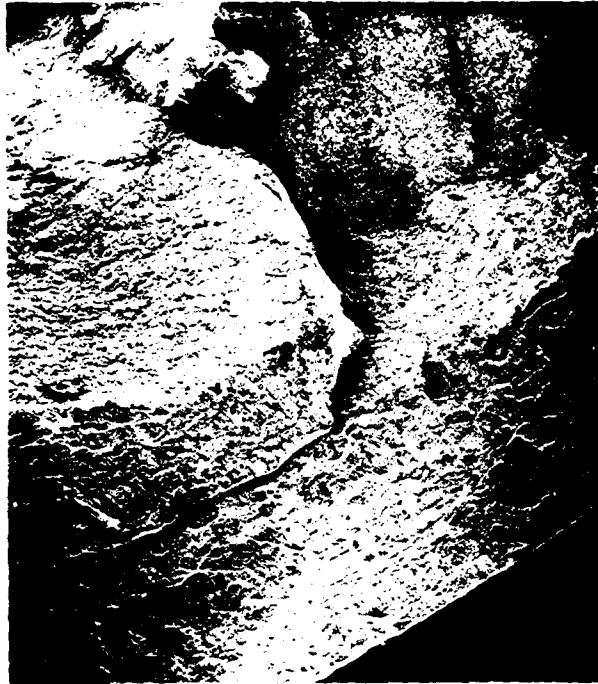
Examination of the cleaned fracture surfaces by the scanning electron microscope revealed extensive grain-boundary separation. Figure 7 shows a crack on the outside edge of one of the bolts; this crack initiated the failure. Figure 8, a higher magnification of Figure 7, clearly reveals the intergranular cracking pattern. The total fracture was not intergranular, however. Figure 9 shows that the tensile overload region consists of a mixed mode of transgranular cleavage and microvoid coalescence.

Figure 7. Circumferential crack on outside edge of bolt (magnified 10 times).

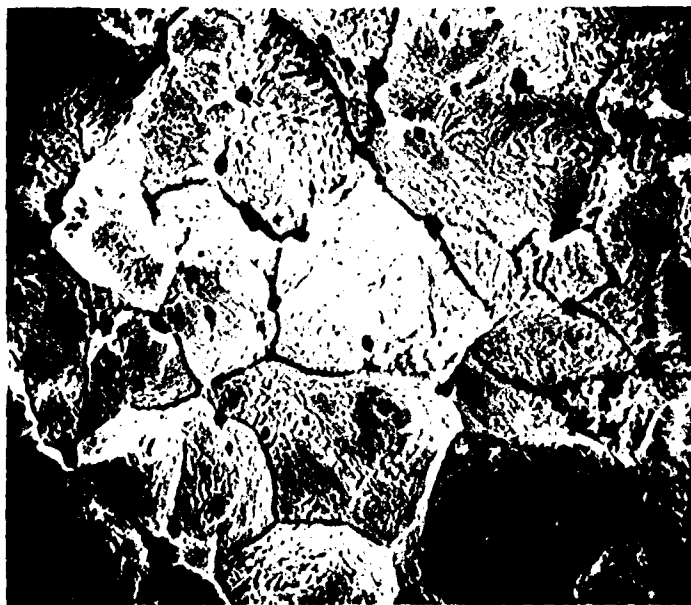
If the steel was temper embrittled, however, intergranular cracks would have developed when the material was exposed to the water environment. Temper embrittlement in stainless steel is believed to be caused by precipitation of a high-chromium ferrite along the prior austenite grain boundaries, depleting the adjacent regions of chromium and lowering their corrosion resistance.³ Thus, when the material is exposed to a corrosive environment, preferential attack, usually in the form of stress-corrosion cracking, occurs at these chromium-depleted regions. The stress-corrosion crack initially propagates as a result of grain-boundary separation. As shown in Figure 8, the initial crack in the bolt was indeed formed by grain-boundary separation.

Figure 8. Intergranular cracks resulting from a grain-boundary separation failure mode (1100x magnification).

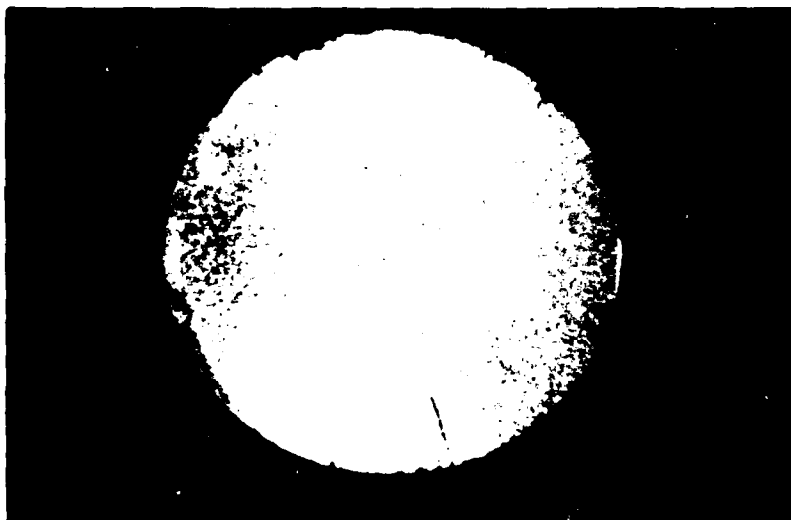
An optical microscopy study of a thin wafer of the bolt sectioned just below the fracture surface revealed two large radial cracks (shown in Figure 10), one of which was about 1/4 in. long. These were the longitudinal cracks discovered during dye-penetrant inspection. A higher magnification of this area, reproduced in Figure 11, showed that the cracks in the martensitic matrix seemed to follow the prior austenite grain boundaries.

Figure 10. Radial cracks in bolt revealed by dye-penetrant inspection (1.45x magnification).

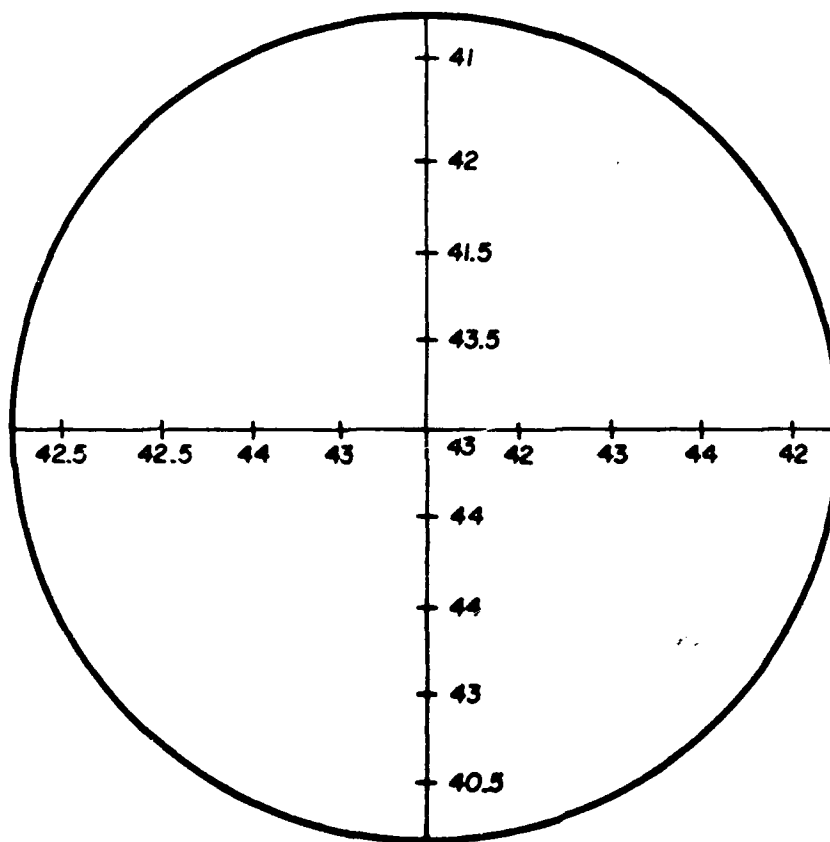
values were taken across cross sections of the broken bolts, and a tensile specimen was machined from one bolt. The results of one of the hardness tests are shown in Figure 12. The average hardness of the bolt was about Rockwell C43. The tensile specimen had a maximum tensile strength of 172 ksi and a 0.2 percent offset yield strength of about 140 ksi.

Rc 40 = BHN: 350

Avg = 43Rc

Figure 12. Results of Rockwell C hardness tests performed on a cross section of a broken bolt.

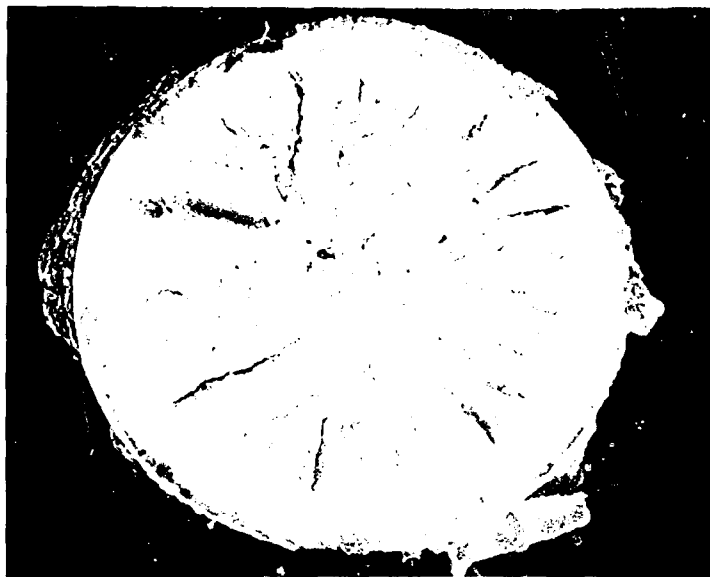
Examination of the fracture surface of the tensile specimens using the scanning electron microscope showed a star-shaped fracture (Figure 13) consisting of dimpled rupture (Figure 14).

Figure 13. Fracture surface of tensile sample (10x magnification).
